# Determination of Radiation Dose Rate and Dose Analysis of Radiation Workers in Radiology Installation at Pariaman Hospital

Ramacos Fardela<sup>1,\*</sup>, Susi Andriati<sup>1</sup>, Feriska Handayani Irka<sup>1)</sup>, Almahdi Mousa<sup>2)</sup>, Ade Wahyuni<sup>3)</sup>

<sup>3</sup>Medical Physicist, Pariaman Regional General Hospital, Pariaman 25514, Indonesia

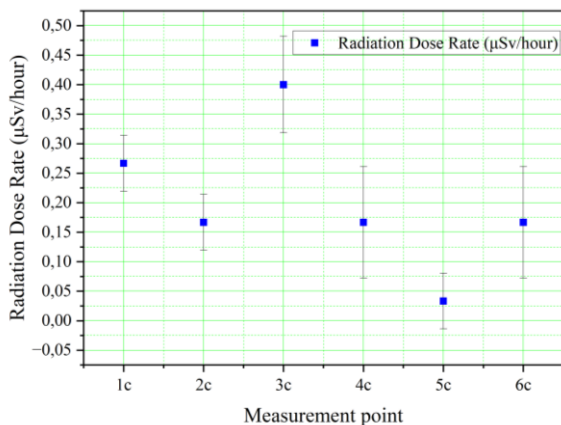
**Figure 4 Distribution of radiation dose rate in the Mammography room**

six different measurement points. As shown in Table 1, shows that measurement point 3c produces the highest radiation dose rate of  $(0.40 \pm 0.08) \mu\text{Sv/hour}$ . Point 3c is a toilet. The lowest radiation dose rate is found at point 5c which is  $(0.03 \pm 0.05) \mu\text{Sv/hour}$ . Point 5c is a patient waiting room.

These results are still below the dose limit value determined by Nuclear Energy Regulatory Agency Regulation No. 4 of 2013. Based on the length of time radiation workers work in a day, the conversion of the dose limit value determined by Nuclear Energy Regulatory Agency Regulation No. 4 of 2013 for workers is  $10 \mu\text{Sv/hour}$  and for the general public is  $0.5 \mu\text{Sv/hour}$ . This is because the radiation shield used is in accordance with applicable standards and the radiation source produces small radiation.

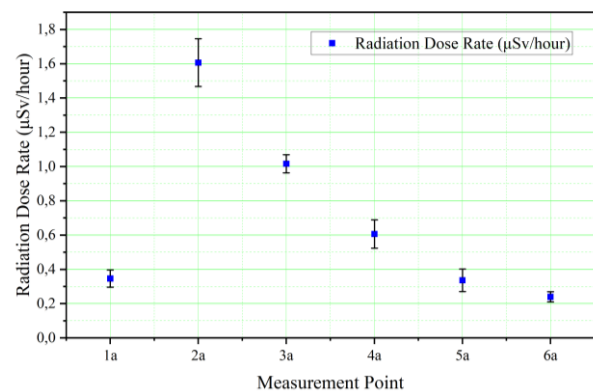
**Figure 5 Radiation dose rate distribution in the CT-Scan room**

In Figure 5, it can be seen that measurement point 2a produces the highest radiation dose rate of  $(1.61 \pm 0.14) \mu\text{Sv / hour}$  where point 2a is the CT-Scan control room officer's door. The high dose rate at that point is thought to be caused by the gap in the officer's door. The lowest radiation dose rate is found at point 6a which is  $(0.24 \pm 0.03) \mu\text{Sv/hour}$  where point 6a is an officer corridor, this is because the distance to the measurement point is far from the radiation source and good radiation shielding so that not much radiation is scattered out. The radiation shielding used is a 4 mm layer of Pb and 28 cm thick concrete.

From this radiation dose value, it is known that there are two measurement points, namely in the parking lot and patient waiting room, there is a radiation dose that exceeds the radiation dose limit for the

community, this is thought to be due to radiation leakage caused by doors or wall structures so that the radiation spread around the room is large.

Because at the measurement point with the highest dose rate value, most of them are on the door. The parking lot and public corridors should also be evaluated to find out why radiation leakage can occur. Checks should be made by examining the structural parts of the walls or windows to detect gaps, cracks or damage to the radiation shielding material. After all the problems have been evaluated, the hospital is expected to quickly make repairs or add protective layers such as lead if there is a shortage in the thickness of the protection.

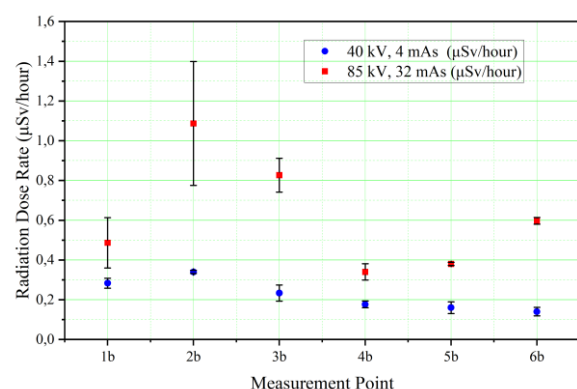
**Figure 6 Radiation dose rate distribution in the conventional X-ray room**

Radiation dose measurements under irradiation conditions with the maximum exposure factor, showed that points 2b, 3b, and 6b exceeded the radiation dose threshold permitted for the general public. This is believed to be due to radiation leakage around the rooms, potentially related to the high intensity of radiation exposure generated, as well as deficiencies in the connecting door structure of the rooms. To address this issue, a thorough evaluation of the design and materials of the room doors is essential to ensure that the escaping radiation is minimized and does not exceed the established dose limits.

Irradiation with a minimum exposure factor obtained radiation doses that are below the radiation dose limit value for radiation workers or the public. This low radiation dose proves that if the exposure factor used is small, the radiation that comes out is also small so that there is no radiation leakage around the room.

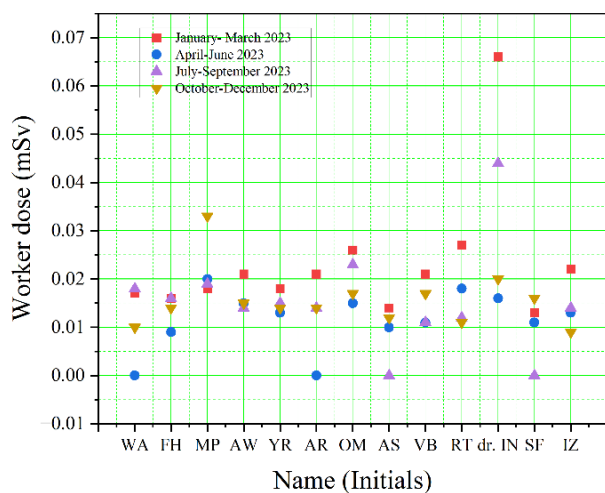
**Figure 7 Dose distribution of radiation workers in 2023**

The highest radiation dose was recorded for the doctor's TLD-Badge, which is thought to be due to the doctor's consistency in wearing the TLD-Badge while in the radiology room. This consistency allows the TLD-Badge to record accumulated radiation exposure more representatively compared to other workers who rarely use the device.

The results of the TLD-Badge reading show that the dose rate received by radiation workers does not exceed the dose limit value set by the Nuclear Energy Regulatory Agency Regulation No. 4 of 2013. However, radiation workers must maintain safety while working so that the radiation dose is as low as possible.

Increased awareness and implementation of radiation safety protocols, including the mandatory routine use of the TLD-Badge, are needed to ensure accurate radiation dose measurement and protection of workers' health.
