**SOCIUS:**

Jurnal Pendidikan dan Pembelajaran Ilmu Pengetahuan Sosial

**MANAGEMENT OF KUIN RIVER USING THE ECO-HYDRAULIC APPROACH**Parida Angriani<sup>1</sup>, Akhmad Munaya Rahman<sup>2</sup>, Karunia Puji Hastuti<sup>3</sup>

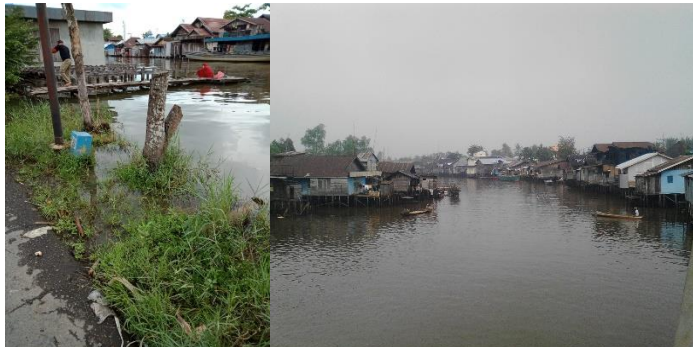
**Figure 2 Condition of Kuin Riverbanks (source: Field Documentation, 2019)**

Along Kuin River, the riverbanks are almost non-existent because they have been converted into land for buildings, which are generally residential areas. The houses that stand on a river body have a length that extends to the middle of the river. The average length of the buildings on Kuin River ranges from 9-10 m. If it is assumed that on the left and right along the river which has a width of 40 m, there are houses of the same length, then the river space is only  $\pm 20$  m. This proves that there is almost no bank along Kuin River and the river has become narrower by the presence of buildings on the river body (Figure 2).

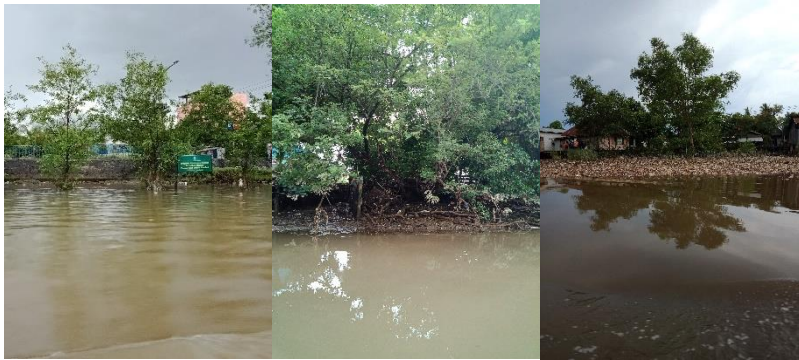
**Figure 3. Types of Vegetation on the banks of Kuin River**  
(source: Field Documentation, 2020)

Based on Table 3 and Figure 3, the types of vegetation that exist on the banks of Kuin River are not natural vegetation that grows in that place, but vegetation that is intentionally planted with the aim of carrying out riverbank conservation. This occurs because along the riverbanks are densely populated with residential areas, causing natural vegetation that should have grown along the riverbanks to disappear because the place where it grows has changed its function to a place of residence. As for the types of fauna in Kuin River, based on Table 4, several types of river fish still exist even though they are increasingly difficult to find. This is a sign that the deteriorating quality of river water can cause loss of river biota.

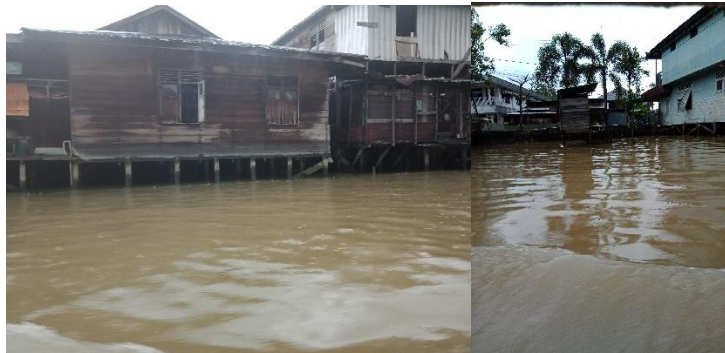
**Figure 5. The condition of the houses on the banks of Kuin River**  
(source: Field Documentation, 2019)

In addition, when viewed from the condition of the residents' houses, the survey results show that most of them look simple, made of ironwood construction with wooden walls. However, there are also those made of stucco cement walls which are semi-permanent. The construction of the stage with ironwood is a characteristic of houses on the riverbank. As for the size of the house, the average length ranges from 9-10 meters with a width ranging from 6-

7 meters. The condition of the houses of the residents on the banks of Kuin River can be seen in Figure 5 below.

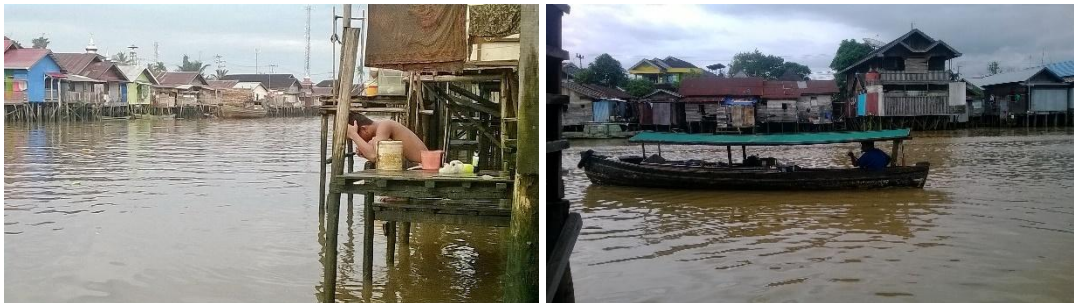
**Figure 6. Utilization of River Water for Daily Purposes**  
(Source: Field Documentation, 2020)

Based on Figure 6, using river water for daily needs such as bathing or washing is something people usually do. This is because no matter how much they take water from the river, they don't have to worry about buying. If they use tap water, every month they have to set aside money for water bill payments. Tap water is only used for cooking and drinking purposes, or when river water feels brackish (a little salty). This situation occurs during the long dry season when sea water intrusion occurs. Table 5 presents data on community activities

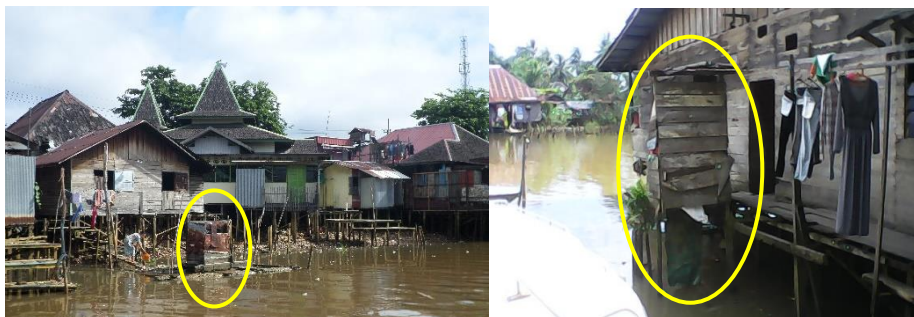
**Figure 7. Condition of the toilets on the banks of Kuin River**  
(source: Field Documentation, 2020)

The direction of waste disposal into rivers has decreased. This is due to increased public awareness regarding waste management. The community realizes that if they throw garbage into the river, it will worsen the quality of river water. However, with regard to the place to defecate, what was observed was the construction of latrines/toilets that were attached to the house as in general, but long before that latrines were built in the form of floating latrines or on trunks (a bridge between residents' houses to the river) (Figure 7). As for the reservoir, the majority of the waste is dumped directly into the river. Table 6 presents data on community activities related to household waste management.
