DENTINO
JURNAL KEDOKTERAN GIGI
Vol VI. No 2. September 2021

**COMPLICATIONS OF RECONSTRUCTION PLATE INSTALLATION
 IN MANDIBULAR
 (CASE REPORT)**

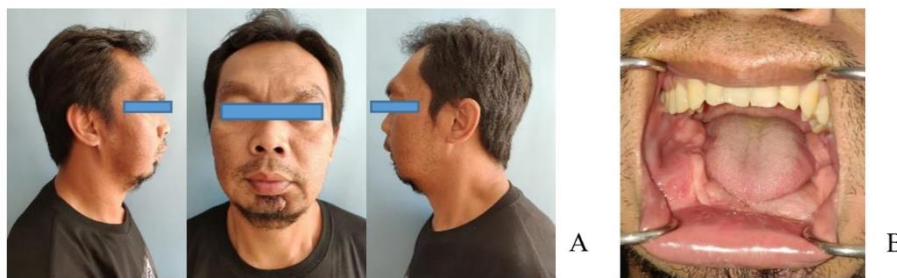
Figure 1. Clinical photograph (A) Extra oral; (B) Intra oral

Extraoral examination revealed facial symmetry with small fistle 1x1x0.5 in size near mentale, ill-defined, slightly erythematous compared to surrounding tissue, and absence of purulent or other liquid (Figure 1.A). Intraoral

examination presented absence of abnormality and colour changes overall mucosa, absence of tenderness, absence of swelling and pus on the vestibule (Figure 1.B).

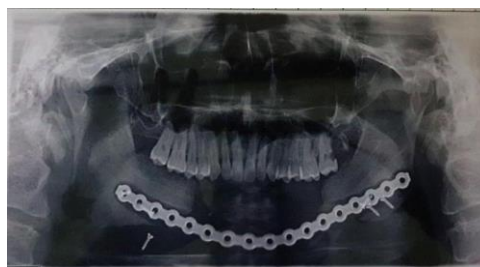
Figure 2. Panoramic radiograph presents radioluscent on anterior border of lower jaw, there is the presence of plate and screw.

Radiologic examination demonstrated the presence of detached screws from plate and radiolucent appearance surrounding the plate that was attached to the mandible. Radiolucent

appearance was observed encircling the plate located on mandible bone (Figure 2).

In this case report, it was reported radiographically that titanium plate was able to restore mandibular unity by applying straight titanium plate in 17 hole non locking system on the mandible with three left screws in left mandible and three screws on right mandible. All screws were detached from plate after one year application and followed by a complaint of erythematous on the chin or dermatitis. Radiographic examination presented the image of detached screws from plate and radiolucent appearance surrounding the plate that remains attached on the mandible (Figure 2). This condition may be associated with the etiology of being allergic to titanium material.

In this case, the color of the chin area is reddish, and radiological images show that the screws and titanium plates are detached from the mandibular bone tissue. Bircher et al. reported five patients who developed complications after knee or shoulder joint replacement, who later discovered a contact allergy to benzoyl peroxide. Reactions experienced by the patient include pain, swelling, pruritis, and loosening of the implant.¹⁹ In dentistry, titanium has been widely used because of its high biocompatibility, but many allergic reactions to titanium have also been reported despite negative results on sensitivity tests.^{18,20} Hypersensitivity can be immediate within minutes, humoral response (type I, II, III reactions) within hours to days. Implant-associated hypersensitivity reactions are generally of the latter type (type IV) i.e. delayed hypersensitivity which can manifest as a failure to adapt the plate to the tissue and various adverse reactions including chronic inflammation.^{10,21} If a hypersensitivity reaction occurs, the titanium is removed with or without the use of metal and recovery can take up to six to nine months.²⁰ It can be concluded that plate exposure is a complication that can occur after the installation of the reconstruction plate, but besides that it can also cause an allergic reaction from the material used. Adaptation of reconstructive plate on mandible is not always received well by human body, therefore in such case it can be decided type of plate material should be able to adapt well such as resorbable plate or autogenous bone graft.

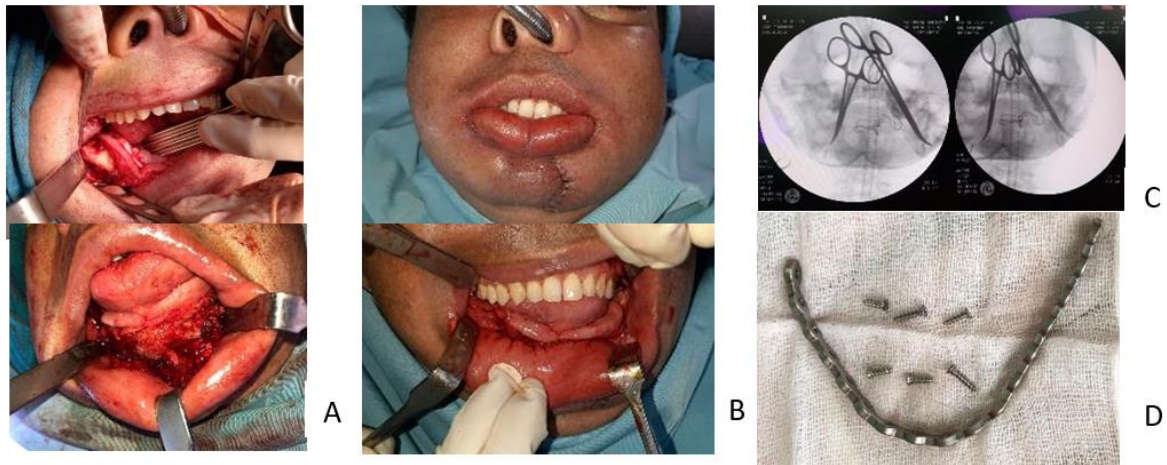
Figure 3. (A) Durante op - plate and screw was removed, (B) Durante op - surgical area was covered and sutured, (C) Imaging picture of C-arm instrument, (D) Plate and screw had been removed from the jaws, imaging result of CPR instrument.

Surgical approach was performed in general necrose to remove screws and plate as well as the removal of fistle in midline region (Figure 3). During surgical treatment, there was complexity to

take the screws from the jaw that C-arm was used to locate the presence of detached screw of the plate (Figure 3.C).

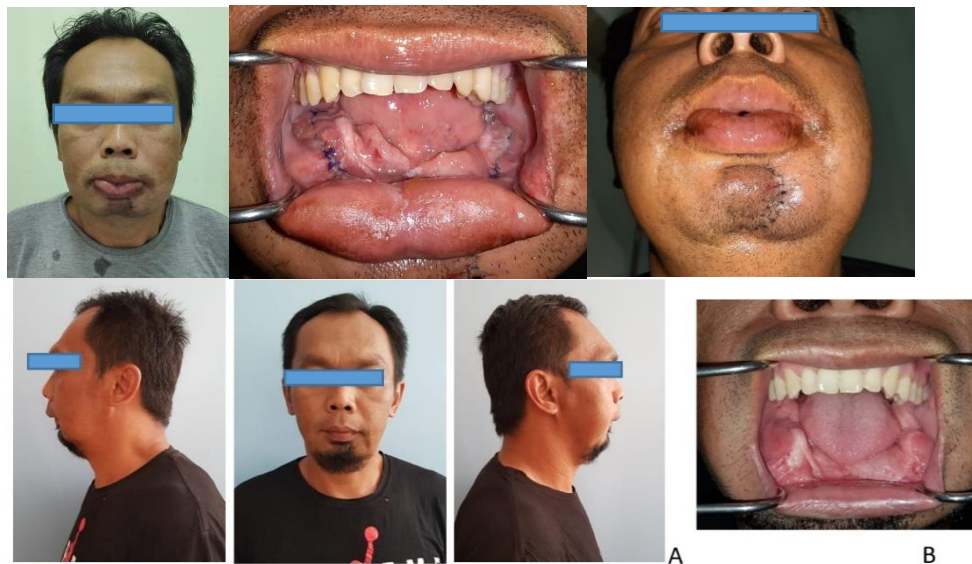
Figure 5. Clinical photograph 4 months after the removal of plate and screw; (A) Extraoral; (B) Intraoral

Patient's condition 4 months after the removal of plate and screws presented with no fistula while intraoral examination resulted in no fistula or other clinical abnormalities. Neither pain nor dermatitis was recorded in the examination (Figure 5). Panoramic radiography shows radiolucent appearance near previously located plate (Figure 6).

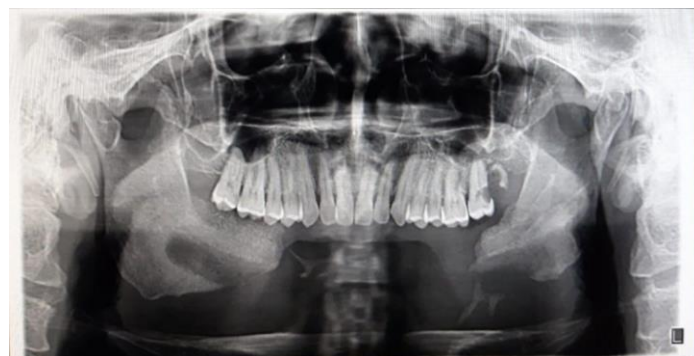
Figure 6. Panoramic radiograph 4 months after the removal of plate and screws.
