# Determination of Radiation Dose Rate and Dose Analysis of Radiation Workers in Radiology Installation at Pariaman Hospital

Ramacos Fardela<sup>1,\*</sup>, Susi Andriati<sup>1</sup>, Feriska Handayani Irka<sup>1)</sup>, Almahdi Mousa<sup>2)</sup>, Ade Wahyuni<sup>3)</sup>

<sup>3</sup>Medical Physicist, Pariaman Regional General Hospital, Pariaman 25514, Indonesia

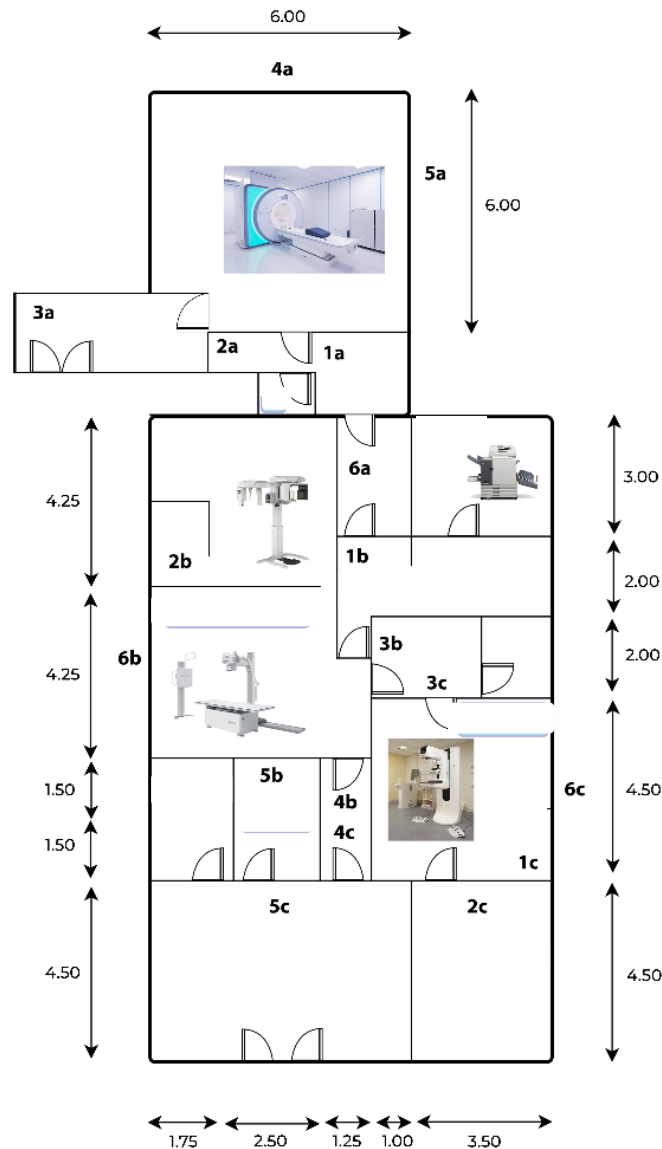
Figure 3 Measurement points

The measurement of radiation dose rate begins with determining the radiation dose measurement point in three radiology rooms, namely CT-Scan, conventional X-ray, and mammography. Each room is measured at six different measurement points using a survey meter. Measurement points in each room can be seen in the Figure 3.

six different measurement points. As shown in Table 1, shows that measurement point 3c produces the highest radiation dose rate of  $(0.40 \pm 0.08) \mu\text{Sv/hour}$ . Point 3c is a toilet. The lowest radiation dose rate is found at point 5c which is  $(0.03 \pm 0.05) \mu\text{Sv/hour}$ . Point 5c is a patient waiting room.

In Figure 5, it can be seen that measurement point 2a produces the highest radiation dose rate of  $(1.61 \pm 0.14) \mu\text{Sv / hour}$  where point 2a is the CT-Scan control room officer's door. The high dose rate at that point is thought to be caused by the gap in the officer's door. The lowest radiation dose rate is found at point 6a which is  $(0.24 \pm 0.03) \mu\text{Sv/hour}$  where point 6a is an officer corridor, this is because the distance to the measurement point is far from the radiation source and good radiation shielding so that not much radiation is scattered out. The radiation shielding used is a 4 mm layer of Pb and 28 cm thick concrete.

Radiation dose rate measurements in conventional X-ray rooms were carried out at six different points with maximum and minimum exposure factors. As shown in Table 3 obtained measurement point 2b produces the highest radiation dose rate of  $(0.33 \pm 0.01) \mu\text{Sv/hour}$ , point 2b is a panoramic room. This conventional X-ray room is adjacent to the panoramic room, but when the conventional X-ray plane is turned on, the panoramic plane is off. The high dose rate at this point is thought to be caused by the gap in the door between the conventional X-ray room and the panoramic room. Measurement point 6b produced the lowest radiation dose rate of  $(0.13 \pm 0.02) \mu\text{Sv/hour}$  where point 6b is a corridor. The radiation shielding used at point 6b is in accordance with applicable standards, namely 28 cm thick concrete coated with 4 mm thick Pb.

Table 4 shows that measurement point 2b produces the highest radiation dose rate of  $(1.08 \pm 0.031) \mu\text{Sv/hour}$ , point 2b is a panoramic room. The high dose rate at that point is thought to be caused by the gap in the door connecting the panoramic room and the distance to the radiation source is quite close. The lowest dose rate value is found at point 4b which is  $(0.33 \pm 0.04) \mu\text{Sv/hour}$ , point 4b is a patient hallway. This is because the shield used is in accordance with applicable standards so that it can absorb all scattering radiation from ongoing irradiation.
